# Manhole Inspection Summary

Manhole # S49CC\_037MH

Insp Date: **2/15/08 9:59 AM**

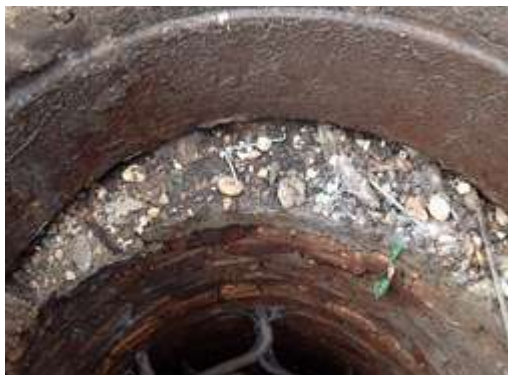
Defect 1

**Frame** Offset: **5** (in.)

Offset

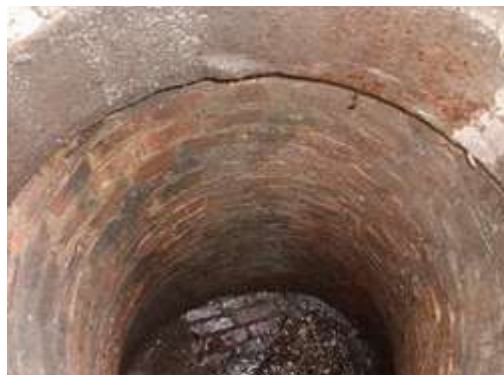
Defect 2

☒ **Leaks**

Frame Leaks

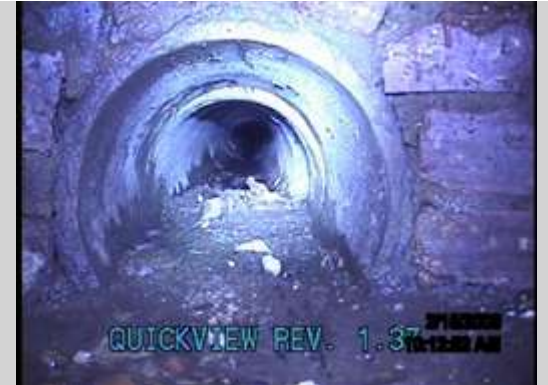
12 O'Clock Outflow

8 in. Circular Gravity Sewer  
Pipe Out @ 12 O'Clock
